Subject: Department of Natural Resources Washington Geological Survey,
School Seismic Safety Assessment Project, Contract No. AE 410 -
Seismic Evaluation for **Ocean Beach School District**

School Buildings Evaluated in the Ocean Beach School District

Ocean Beach, Ilwaco (Hilltop) Middle School, Auditorium

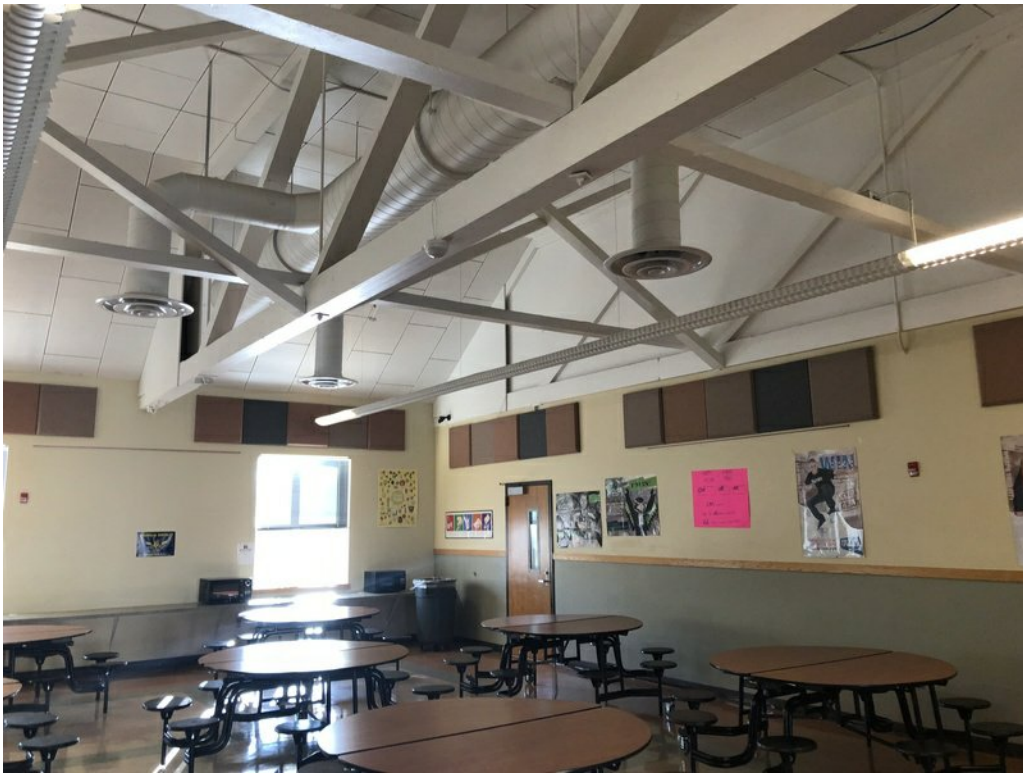
Figure 1-4. Cafeteria Interior

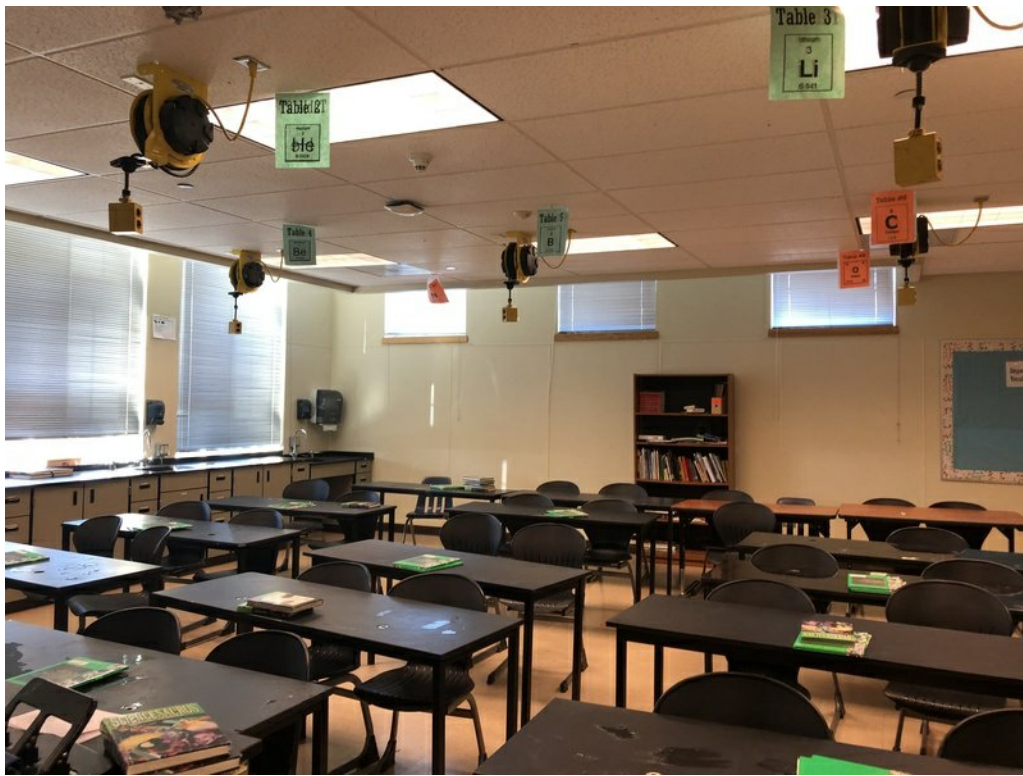
Figure 1-10. Typical Classroom with Non-Compliant Light Fixture Bracing

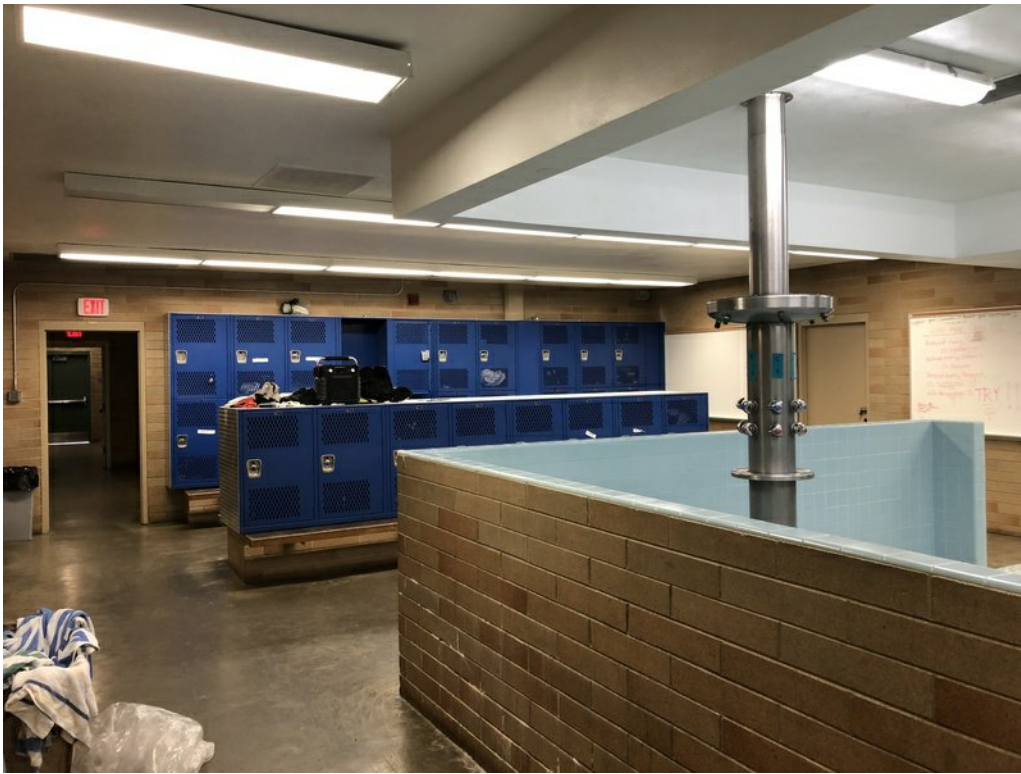
Figure 1-9. Unbraced Nonstructural Masonry Half-Walls in Locker Room

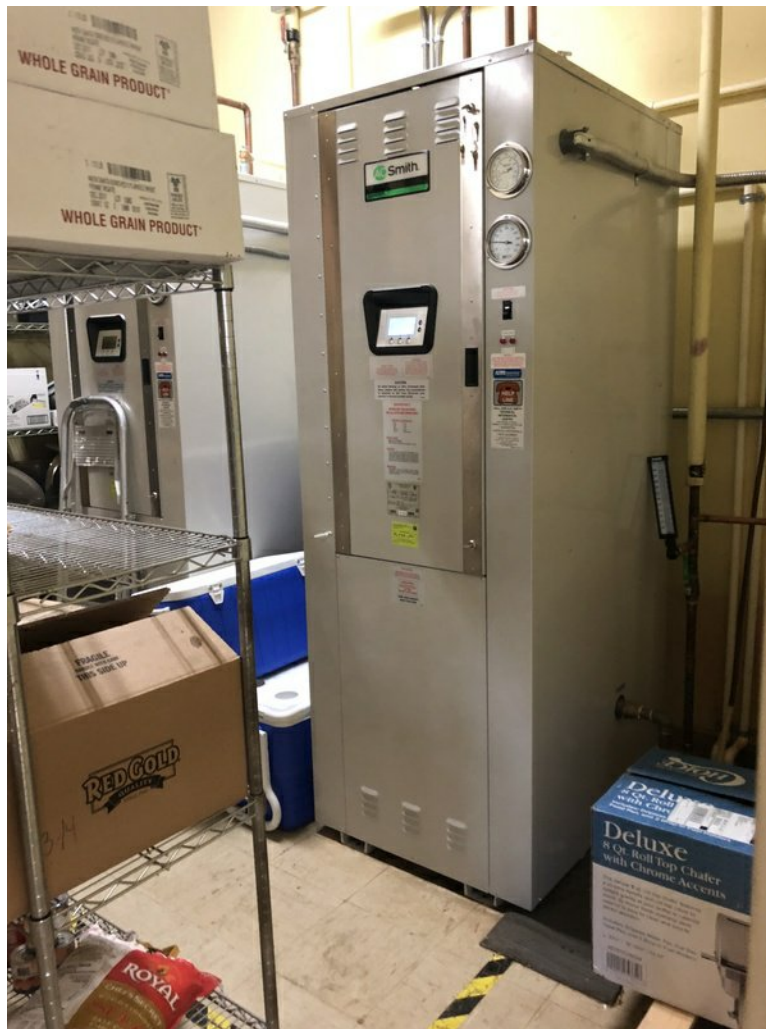
Figure 1-10. Tall Unbraced Nonstructural Components, Typical Throughout

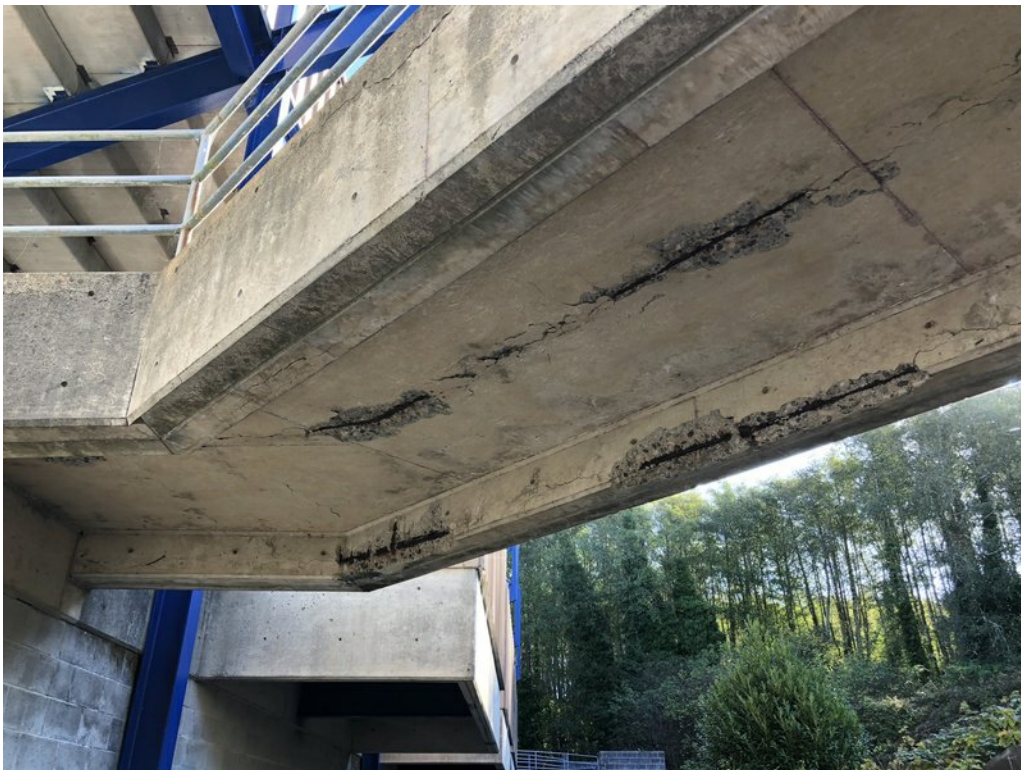
Figure 1-5. Cracking and Spalling of Concrete

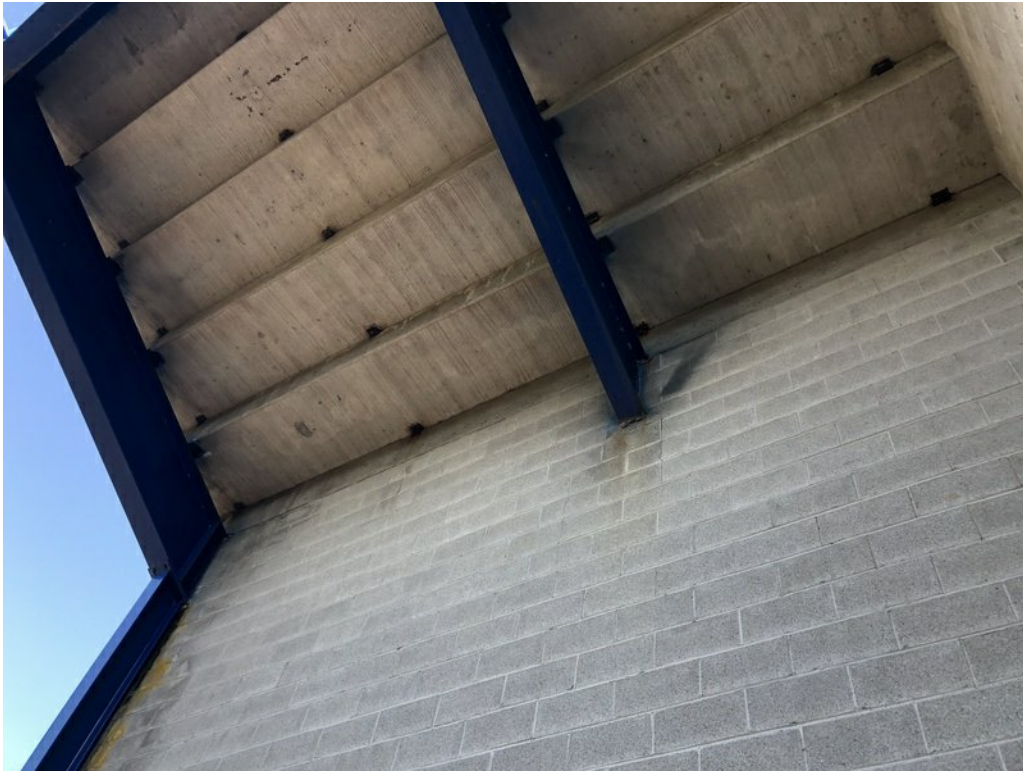
Figure 1-6. Underside of Precast Seating with Cracking in Masonry Wall at Steel Beam Bearing

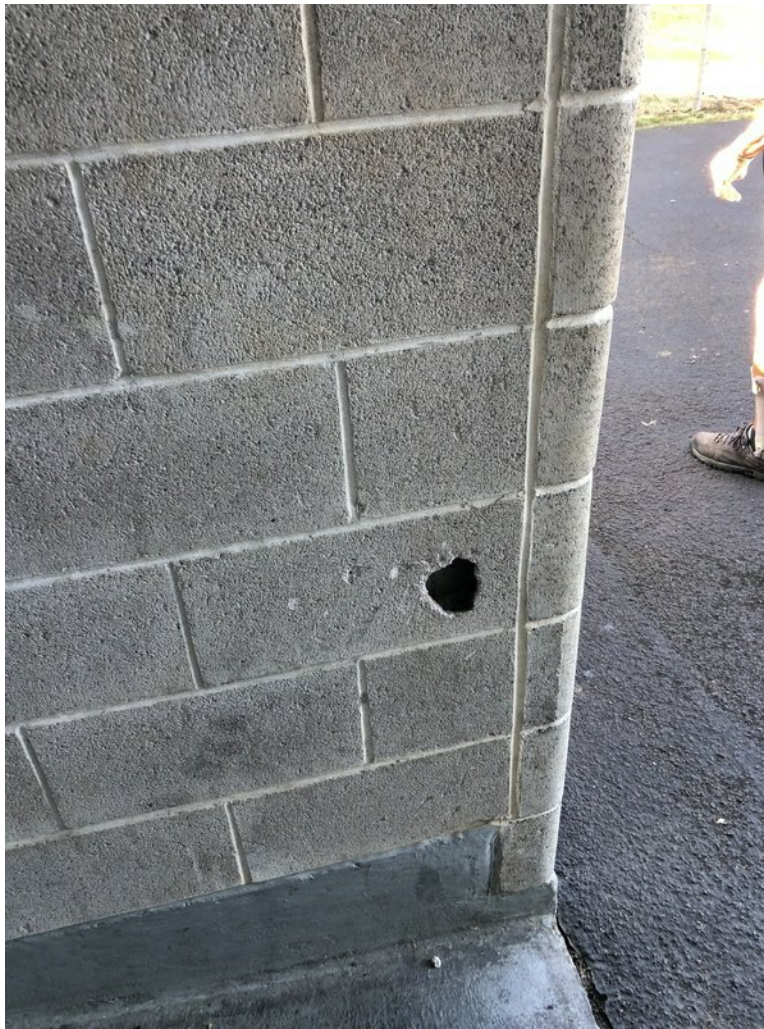
Figure 1-7. Holes in Masonry Wall Typical.

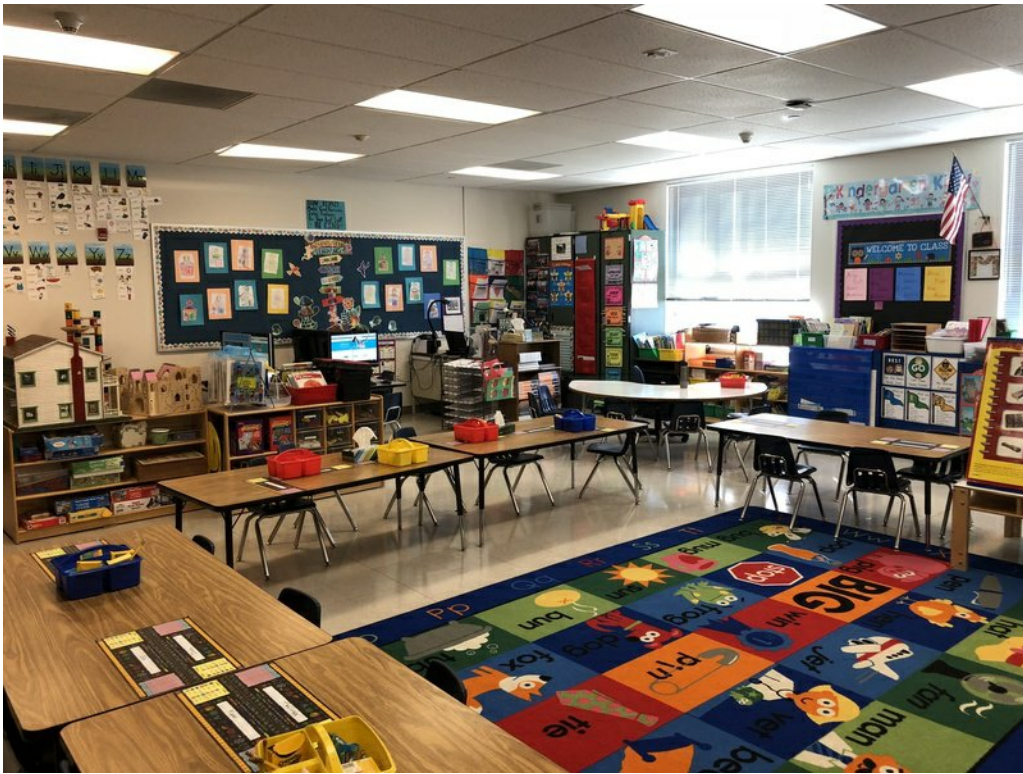
Figure 1-7. Typical Classroom with Unknown Light Fixture Bracing

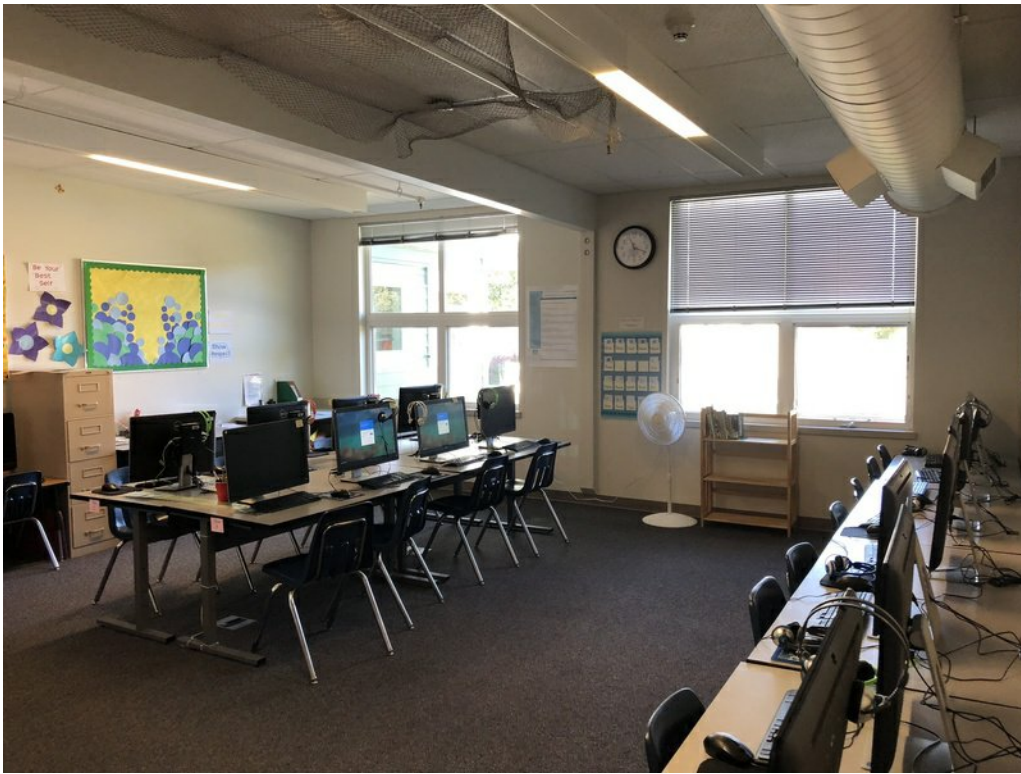
Figure 1-9. Computer Lab with Unbraced Ducts/Piping

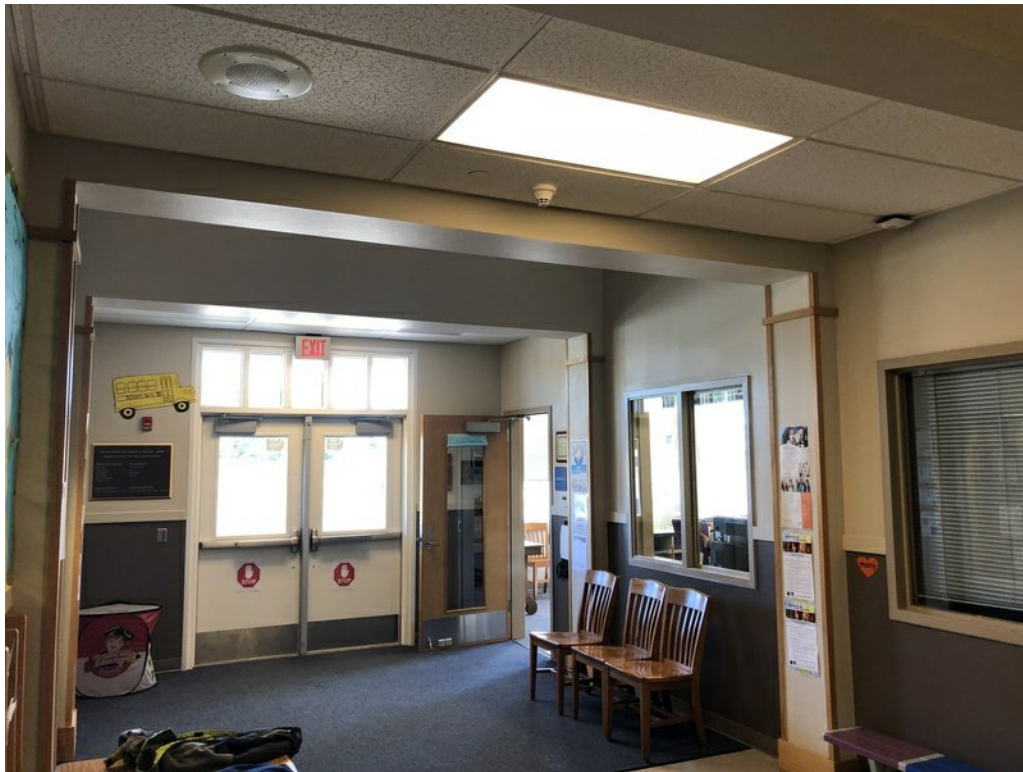
Figure 1-1. Typical Hallway with Unknown Light Fixture Bracing

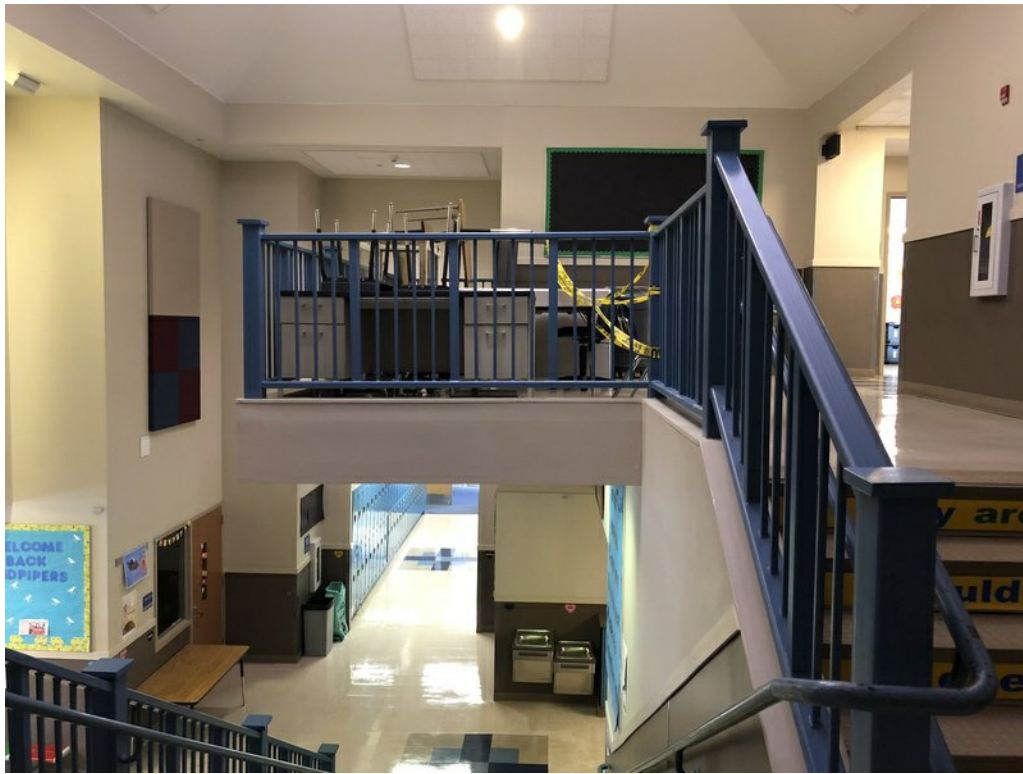
Figure 1-3. Stairway with Unknown Seismic Detailing
